## K149A, K149B, K150 Hardware Modification

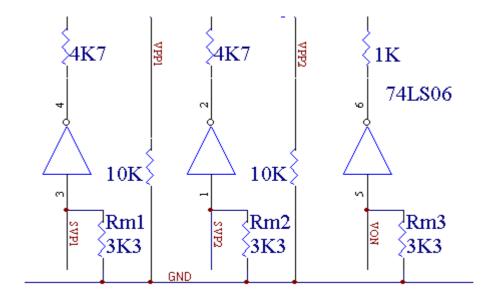
For K149-A(B), one resistor end is soldered to each of the 74LS06 chip on pins 1, 3 and 5. The other ends are soldered to ground (pin 7).

For K150, one resistor end is soldered to each of the PIC socket pins 11, 12 and 13. The other ends are soldered to ground (pin 5).

See the diagram below.

This requires the addition of three (3) 3K3 1/4W resistors - Rm1, Rm2, and Rm3.

These can be soldered underneath the PCB.

Disconnect power and carefully remove the PIC16F628 chip from its socket before attempting to solder the resistors in place.

After soldering the resistors, replace the PIC chip and after verifying that it is inserted correctly, apply power. With the negative lead of a multimeter connected to ground, use the positive lead to make sure that there are no voltages present in the programming socket.
